## Fatalgrams and Fatal Reports

Fatality #45 - November 5, 2006 Electrical - Surface - AZ Peabody Western Coal Company – Kayenta Mine

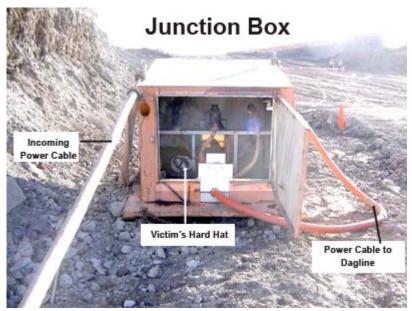
**COAL MINE FATALITY -** On Sunday, November 5, 2006, a 52-year old electrician with 21 years of mining experience was fatally injured while troubleshooting the trailing cable for a Marion 8200 dragline at a surface coal mine. The electrician was working at an electrical junction box that supplied power to the dragline when he contacted two 23,000 volt energized phases in the junction box. Incoming power to the junction box had been disconnected and locked out by the electrician. A diesel powered generator onboard the dragline was started and caused 480 volts to be back fed through onboard transformers, energizing the phases.

- Ensure that equipment is de-energized, locked out, and tagged before performing electrical work. Do not rely on someone else to do these things for you.
- Thoroughly communicate to determine that it is appropriate to reset a breaker.
- Ensure that electrical work is only performed by a qualified person or one trained to perform electrical work under the direct supervision of a qualified person.
- Never assume that you know how a circuit is wired. Ask for help and/or consult a wiring diagram/schematic if you are unsure.
